NBSIR 81-2324 (R)

# Boiling Tests of Non-Asbestos-Based Thermal Insulation Used in Air-Conduit Underground Heat Distribution Systems

September 1981

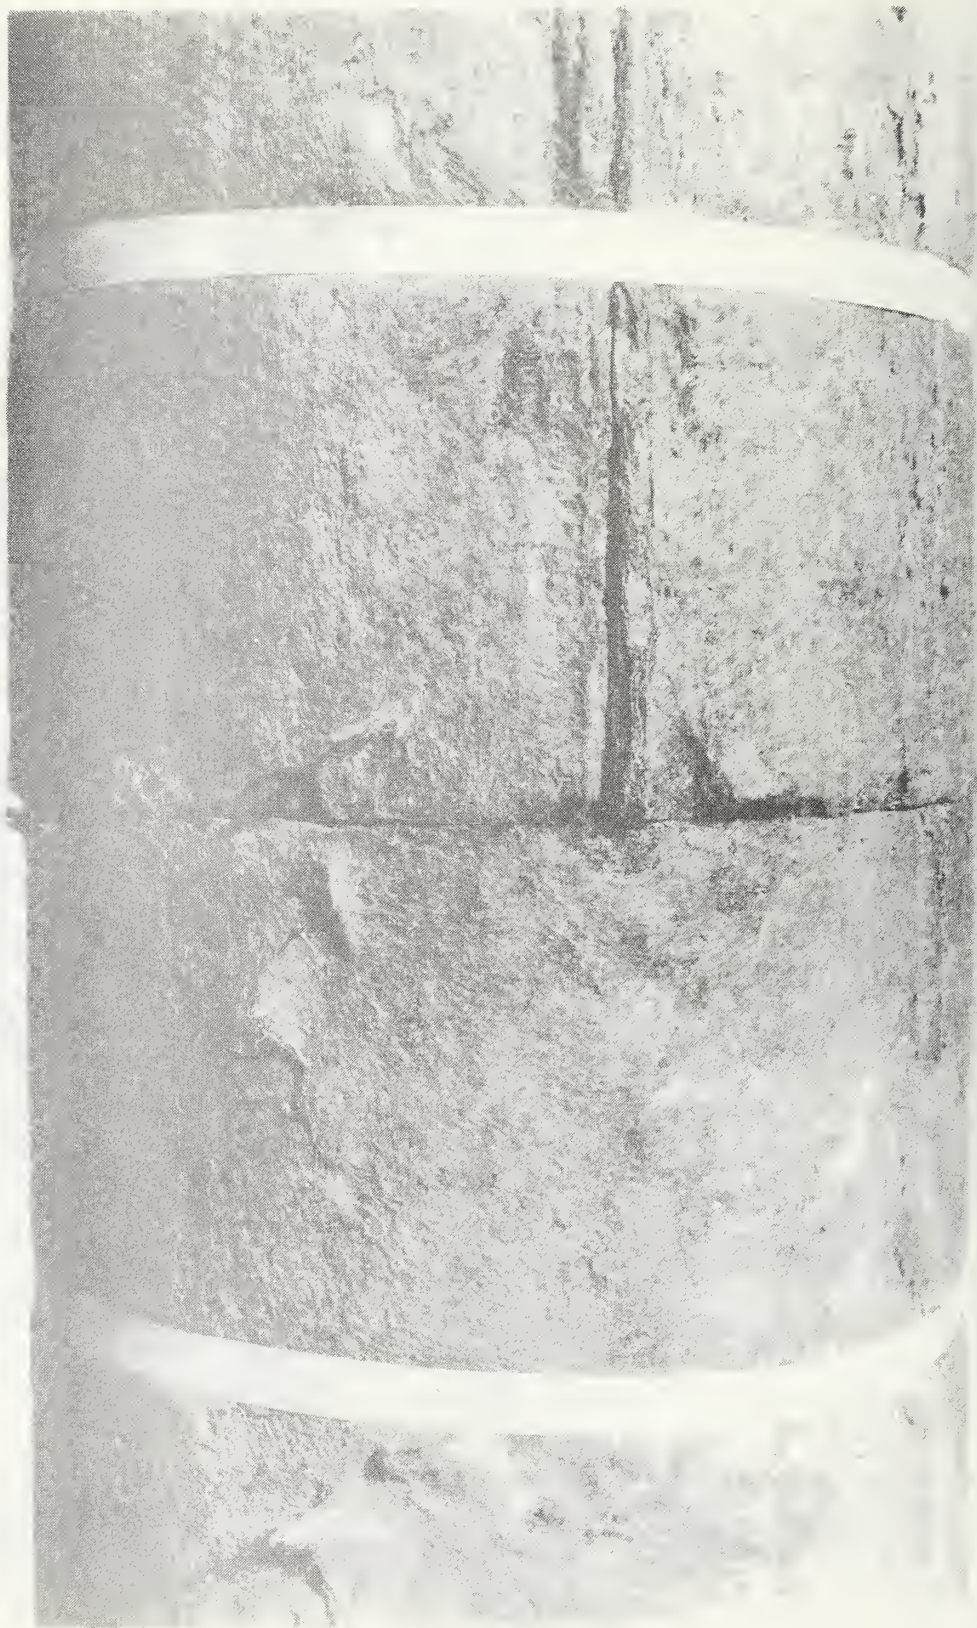
The insulation removed from the conduit after boiling for 96 hours and drying is shown in figure 53. Figure 54 shows close-up of the insulation at the bottom of the pipe (below the water level) after boiling. Figure 55 shows close-up of the insulation at the top of the pipe (above the water level) after boiling.

Figure 55. Close-up of Epitherm at the top of the pipe after boiling (above the water level).

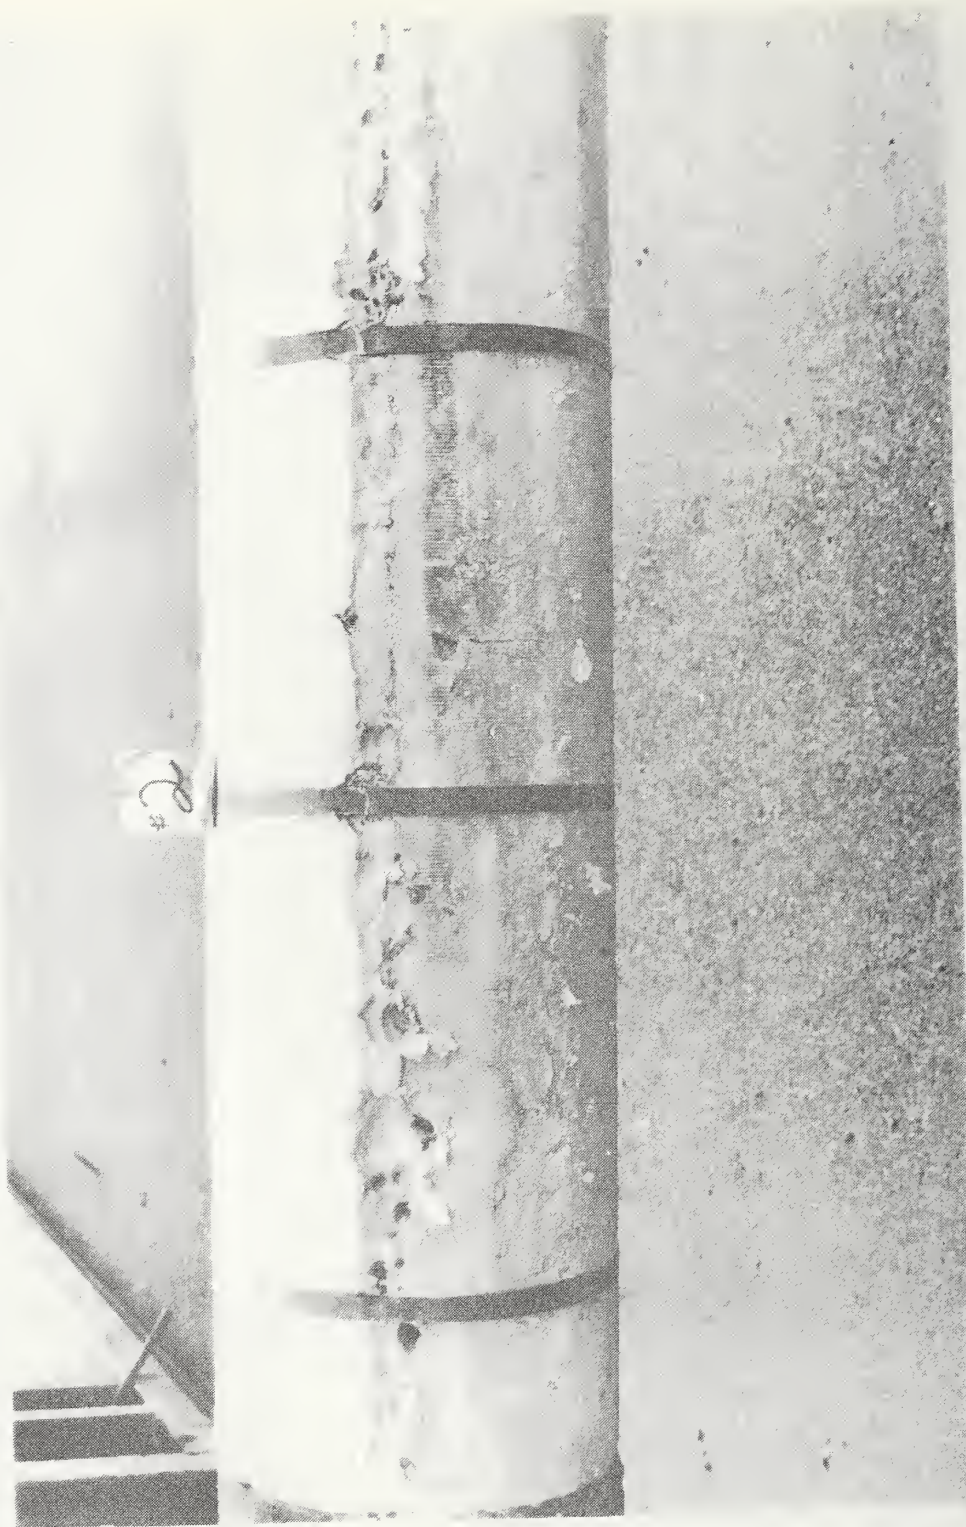
Insulation Material	Days Boiling			
	8	16	24	32
				64
Celotemp 1500 Celotex Corp. Expanded perlite	Started breaking apart Figure 61	Final run insulation 50% off of pipe. Figure 62	---	---
Thermo-12 Johns-Manville Calcium silicate	No physical damage visible to insulation.	Started to show damage. Figure 63	Increased damage apparent. Figure 64	Continuous damage apparent. Figure 65
Epitherm 1200 Eagle-Picher Mineral wool	Slight damage apparent Figure 67	Slightly increased damage. Figure 68	Damage at support on end. Figure 69	Slight increased damage. Figure 70
Wesolite "D" Wesolite Co. Perlite/sodium silicate	Damage below water level. Figure 72	Joint opening slightly Figure 73	Slight damage at joint. Figure 74	Damage at end of section. Figure 75
Super Caltemp Pabco Calcium silicate	No physical damage visible to insulation.	Cracks visible in insulation. Figure 77	No increase in damage visible. Figure 78	Damage below water level. Figure 79

Figure 64. Thermo-12 after 24 days of boiling.

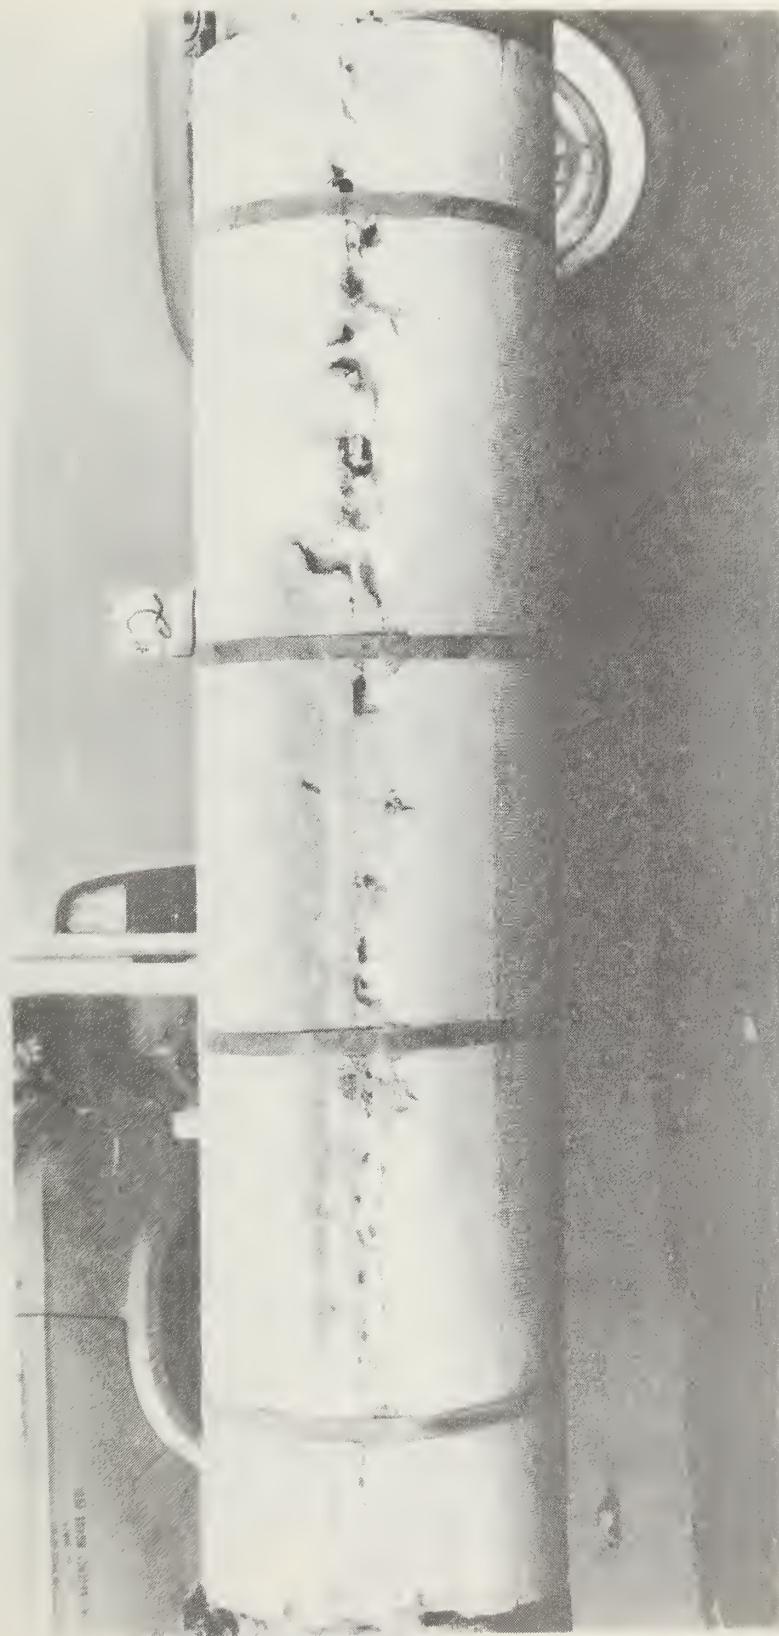
Figure 65. Thermo-12 after 32 days of boiling.

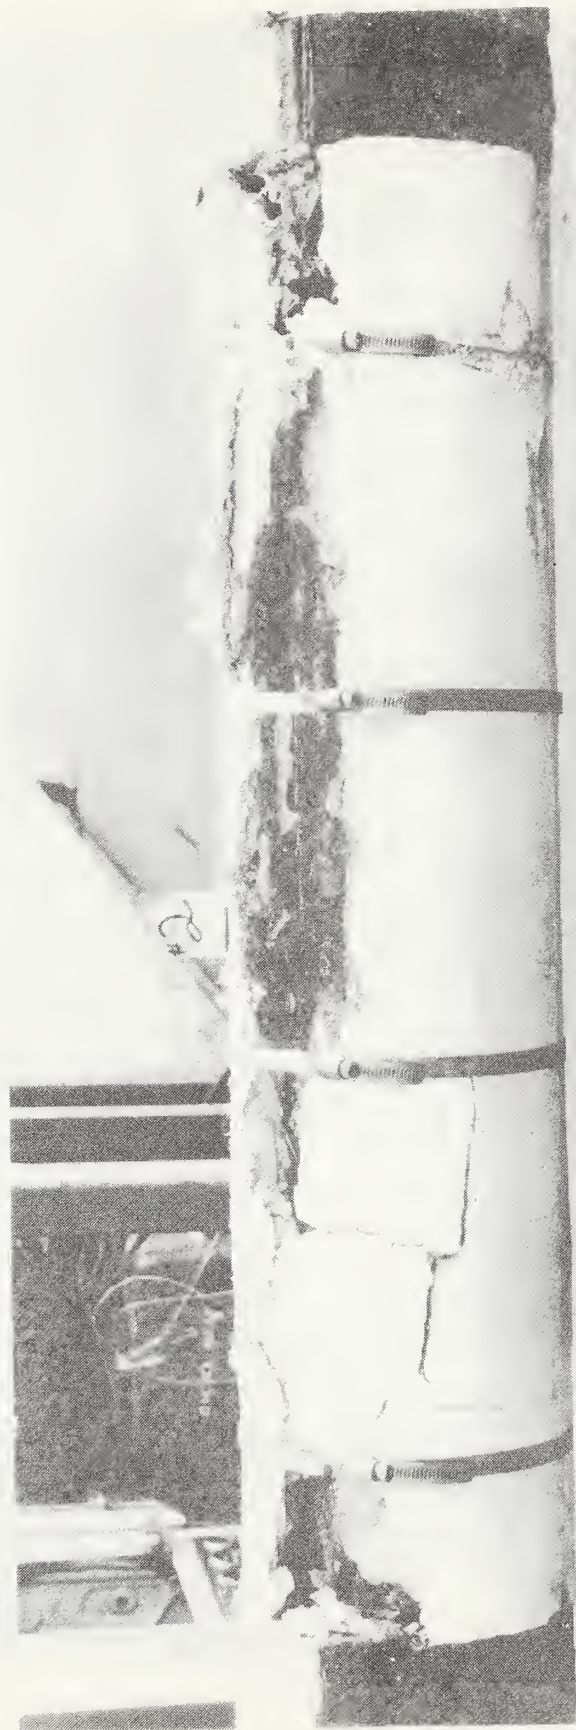
Figure 66. Thermo-12 after 64 days of boiling.

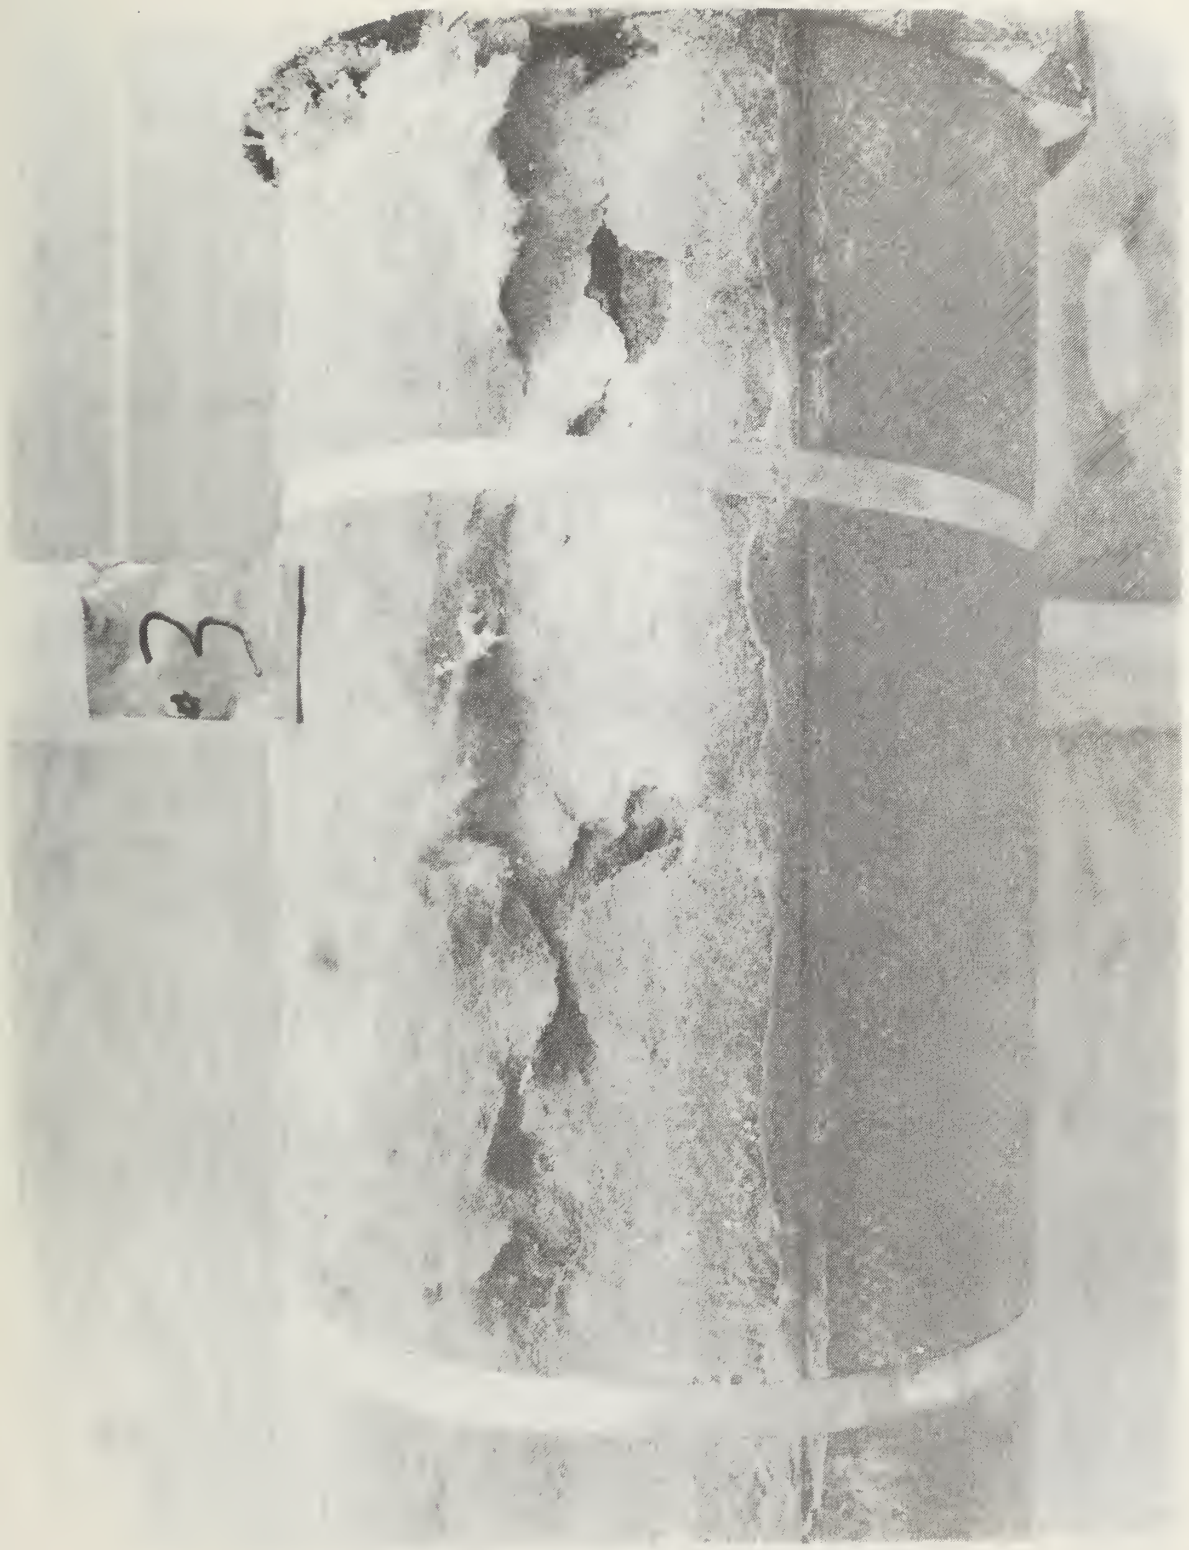
Figure 67. Epitherm 1200 after 8 days of boiling.

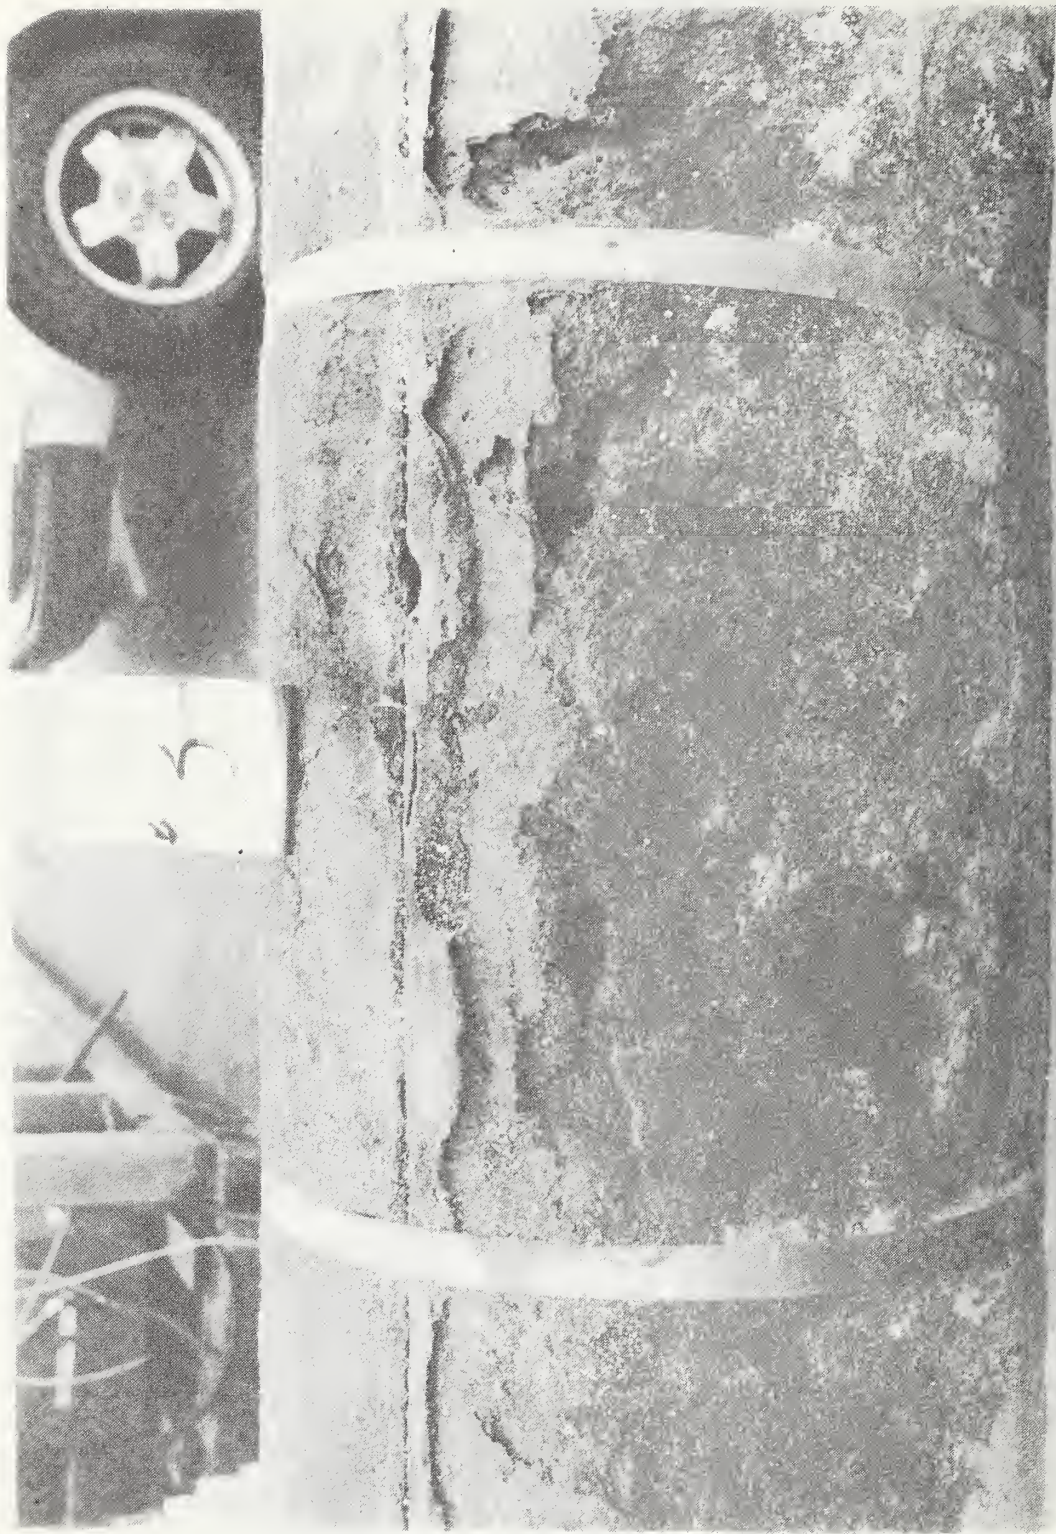
Figure 68. Epitherm 1200 after 16 days of boiling.

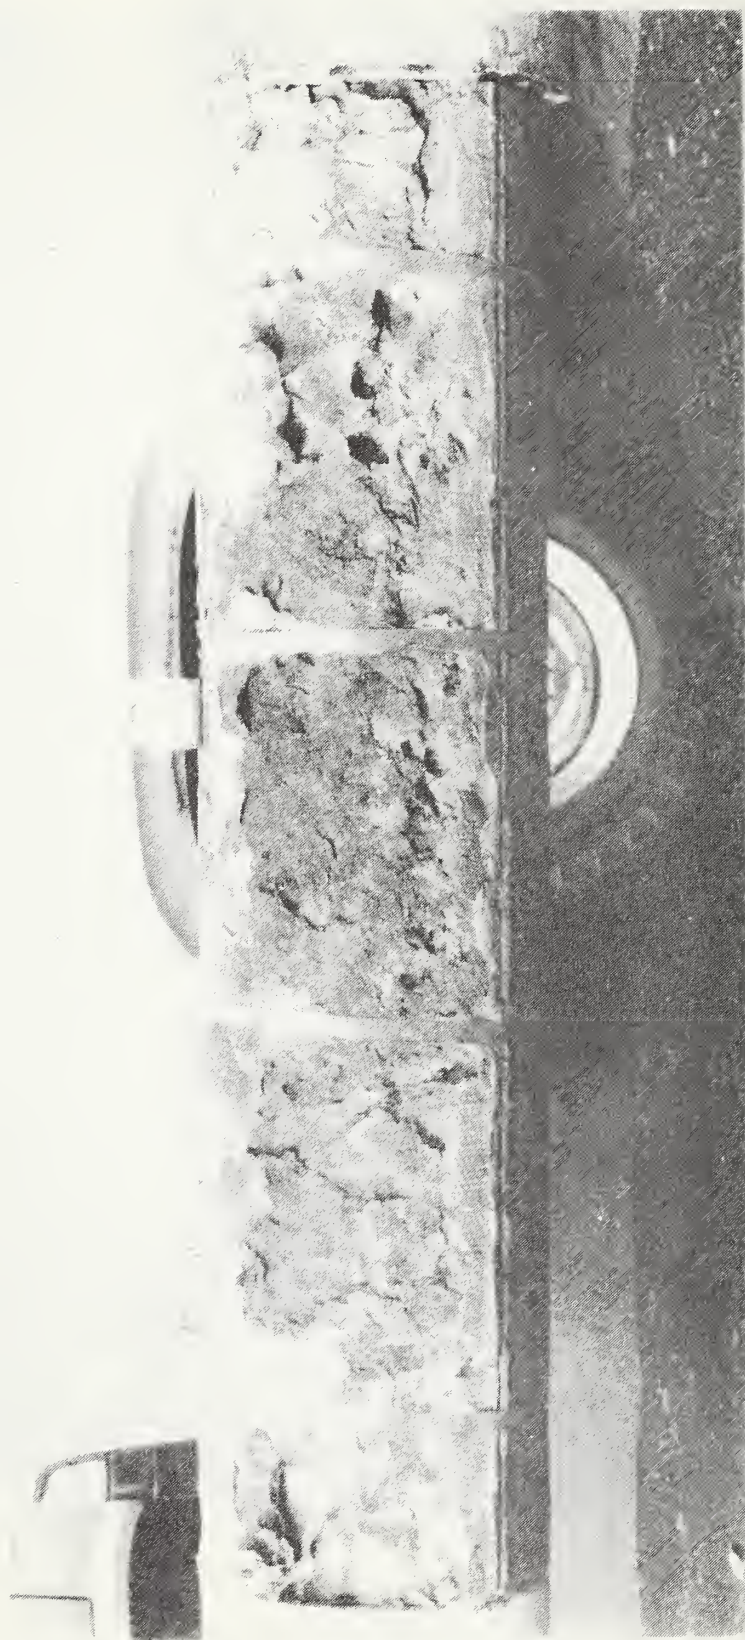
Figure 70. Epitherm 1200 after 32 days of boiling.

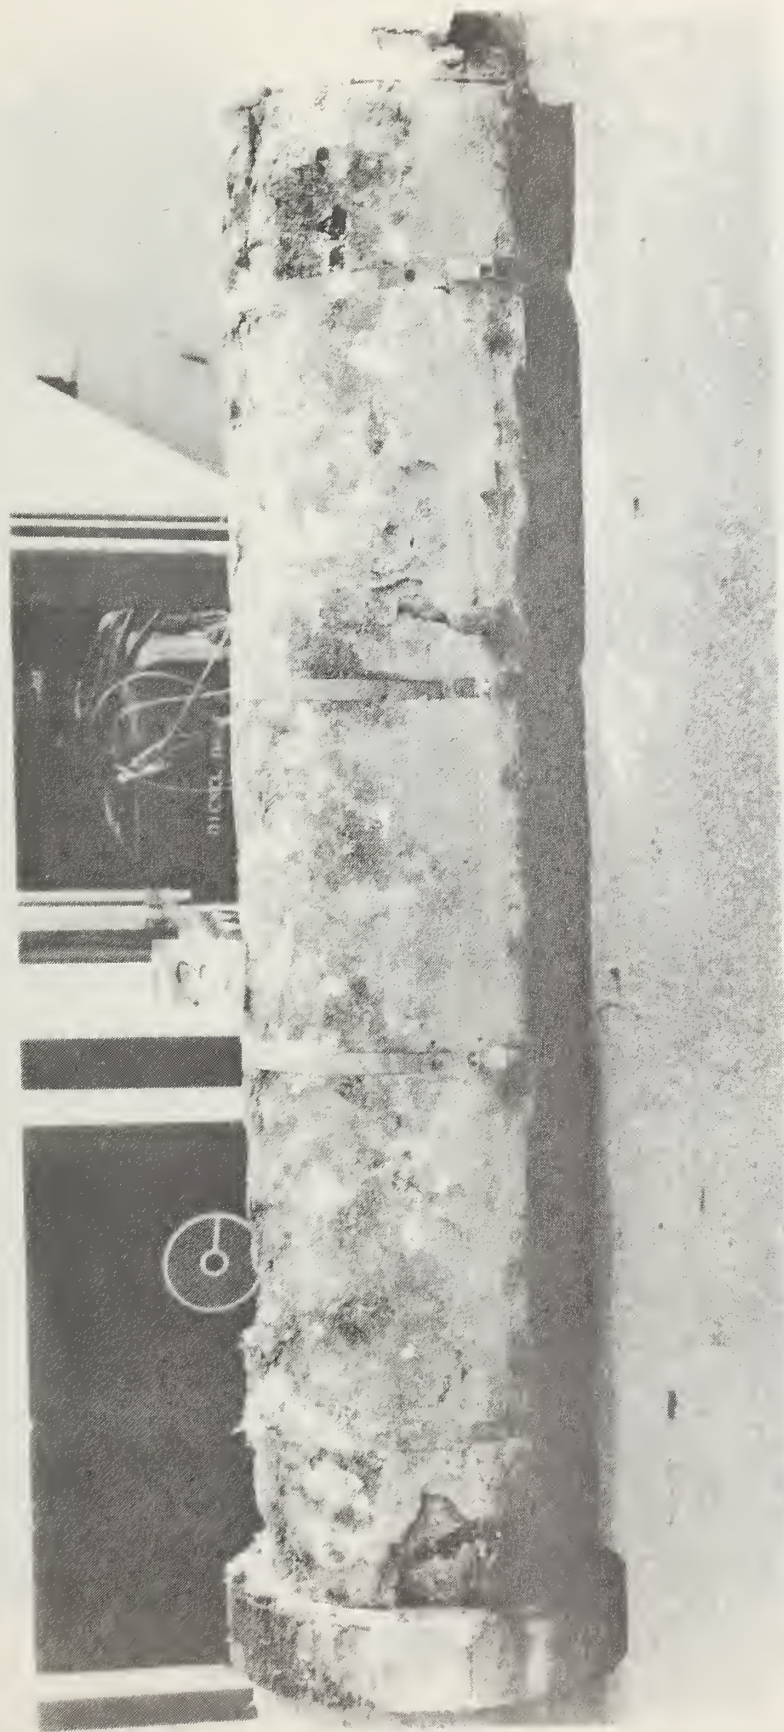
Figure 71. Epitherm 1200 after 64 days of boiling.

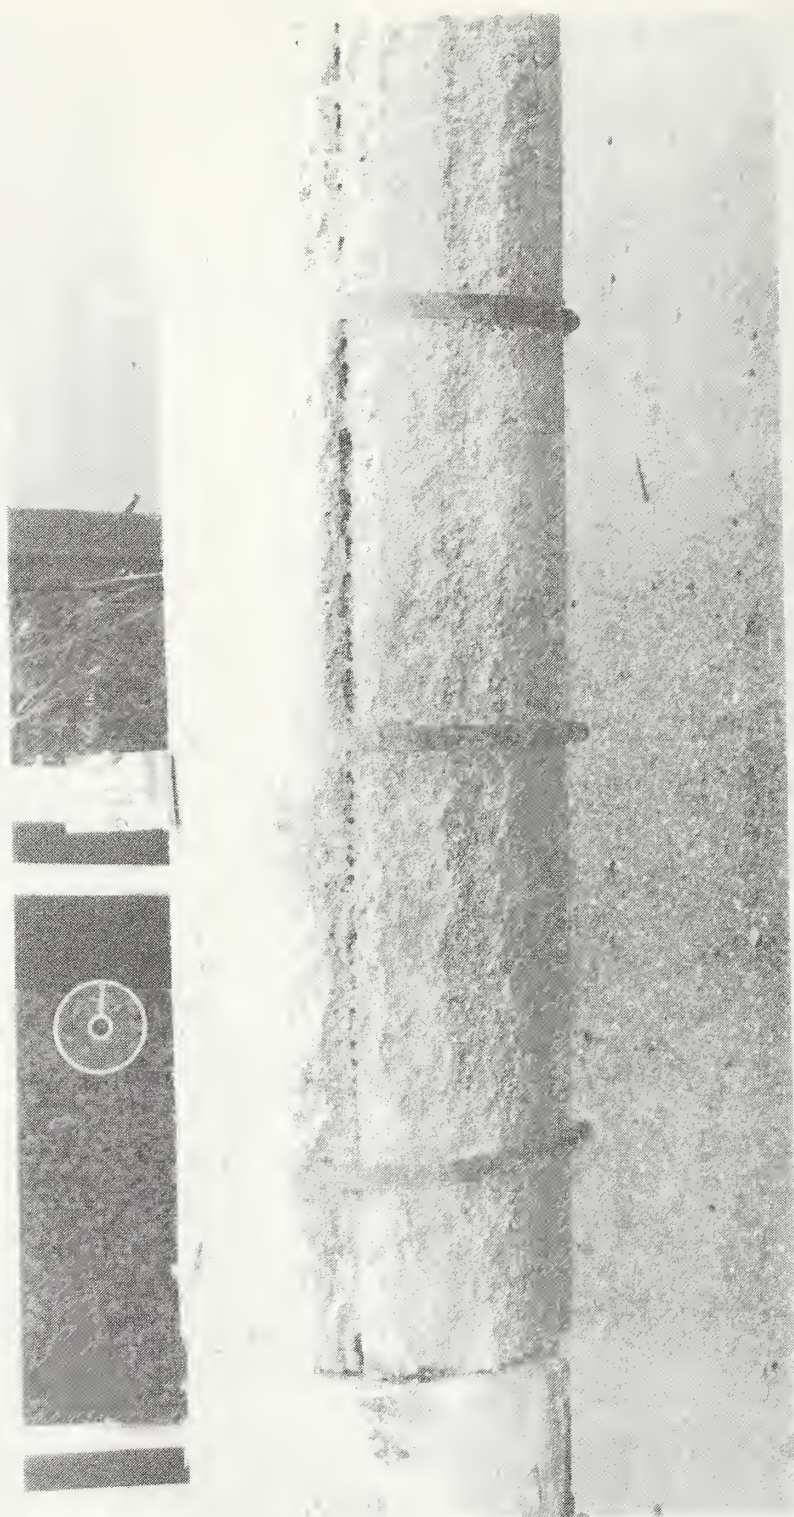
Figure 74. Wesolite "D" after 24 days of boiling.

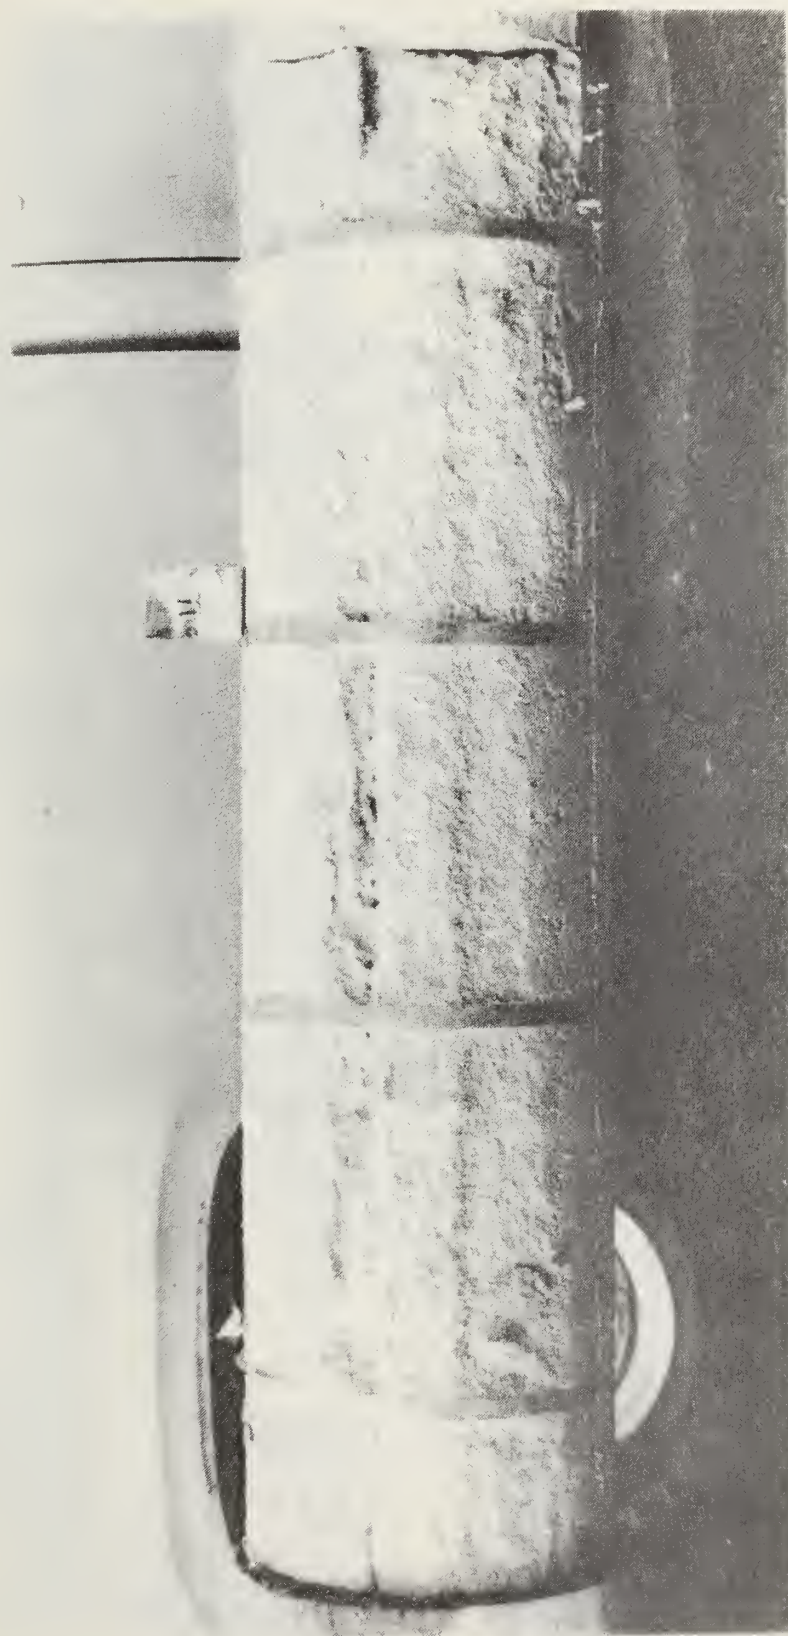
Figure 75. Wesolite "D" after 32 days of boiling.

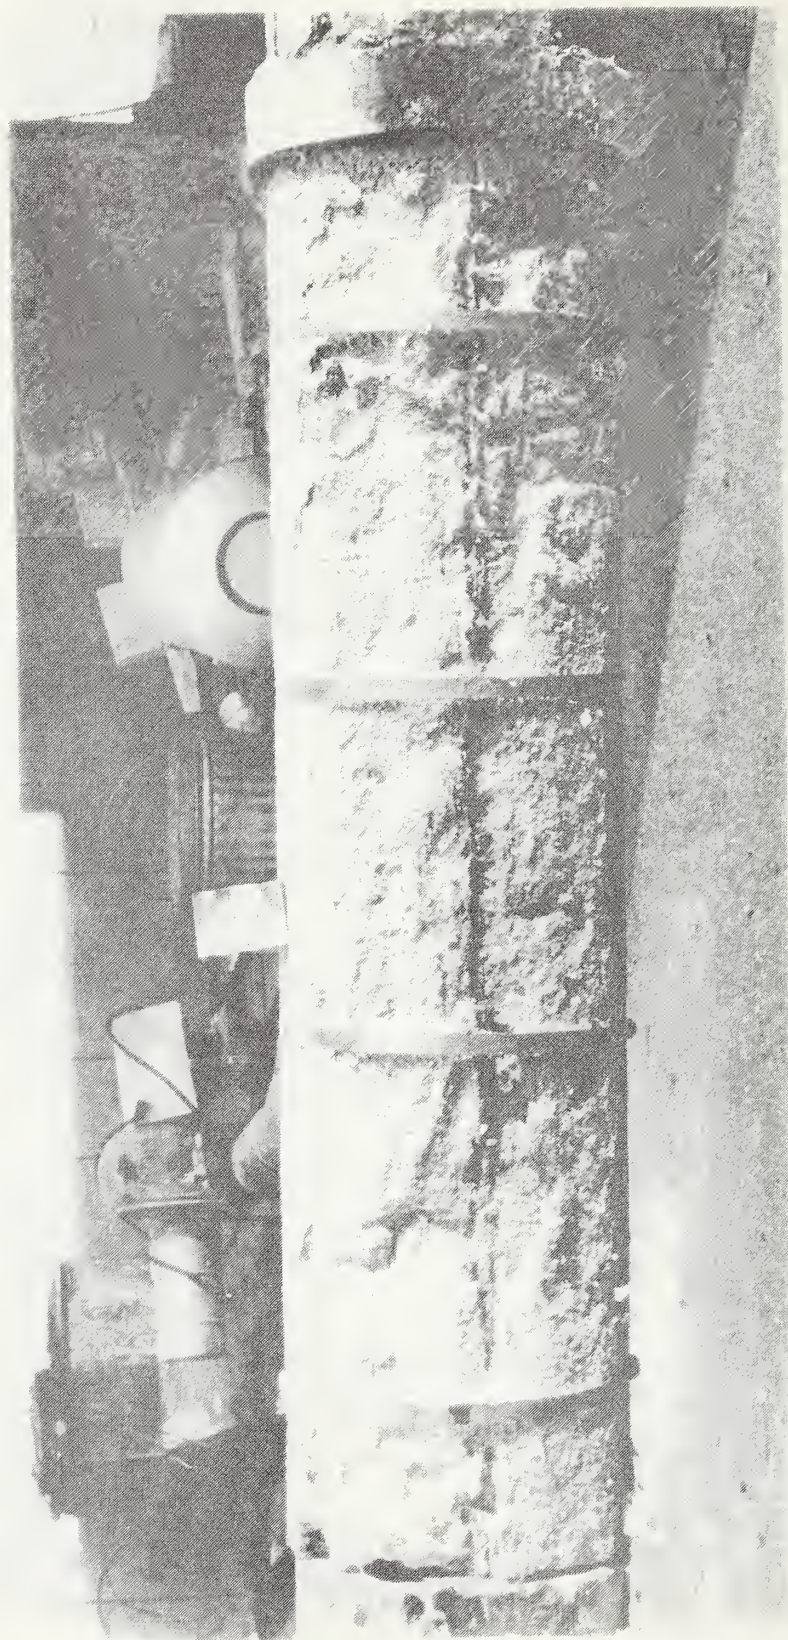
Figure 76. Wesolite "D" after 64 days of boiling.

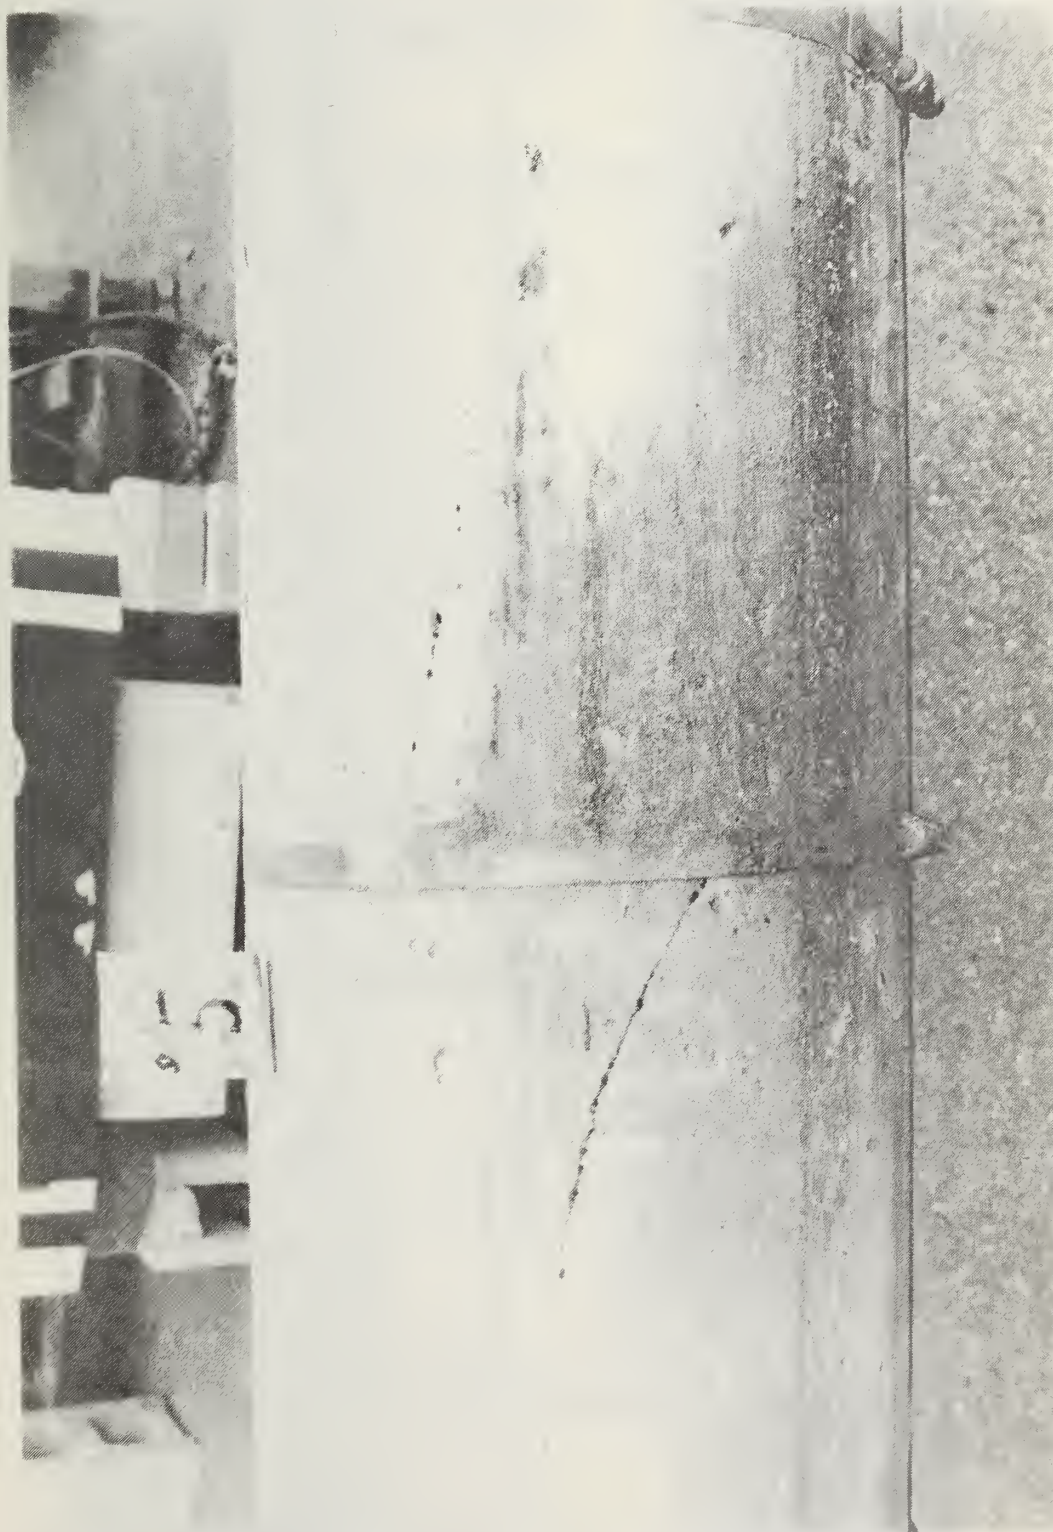
Figure 77. Super Caltemp after 16 days of boiling.

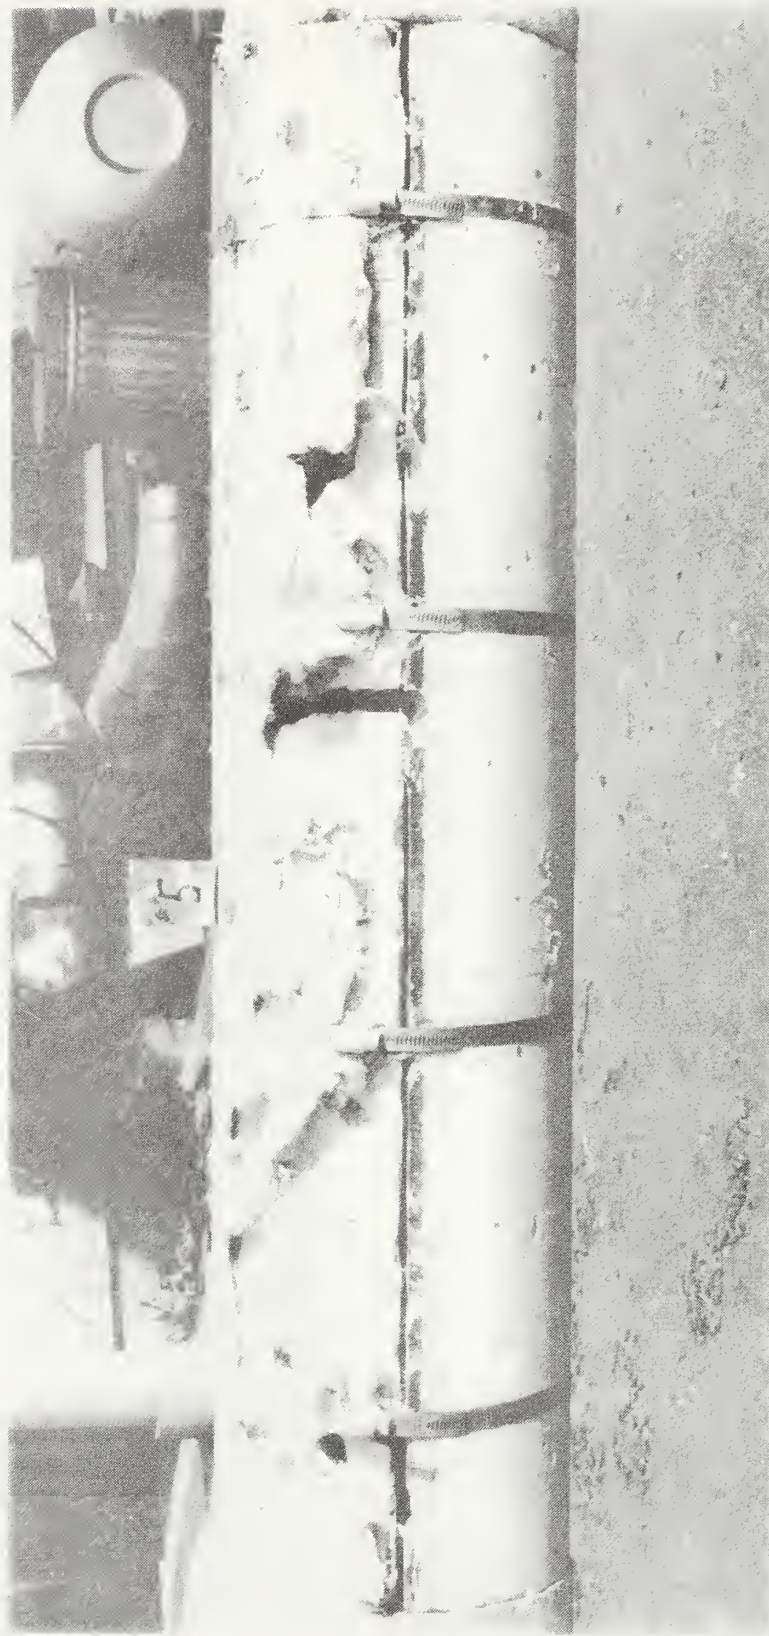
Figure 80. Super Caltemp after 64 days of boiling.

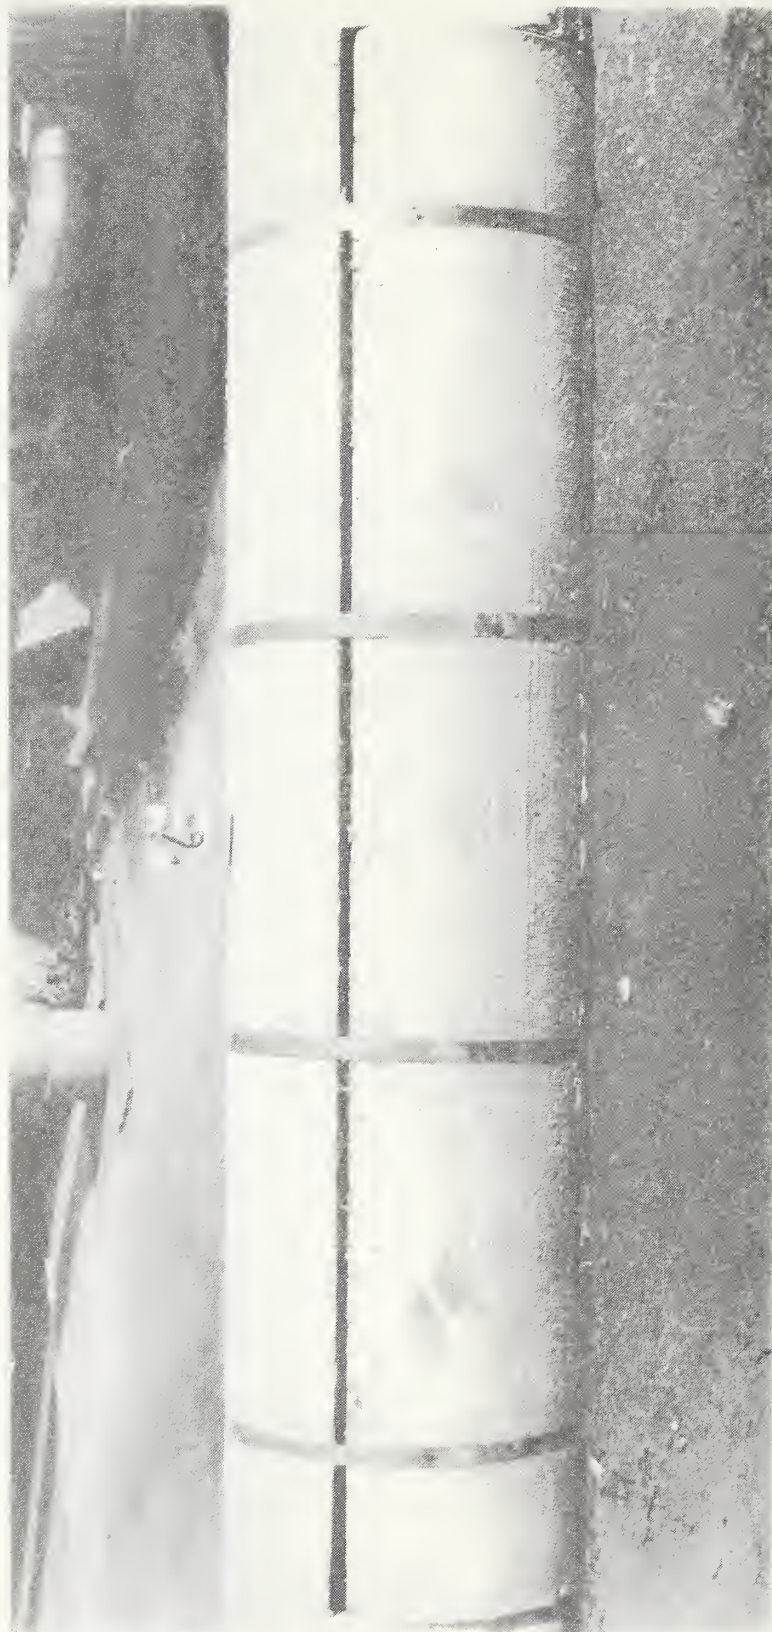
Kaylo-10 Owens/Corning Calcium silicate	No physical damage visible to insulation.	Slight damage visible. Figure 81	Damage at joint visible. Figure 82	Joint starting to open up. Figure 83
				Increased opening at joint. Figure 84

Figure 84. KAYLO-10 after 64 days of boiling.
